NASA/TM—2009-215629

# The Effects of Hot Corrosion Pits on the Fatigue Resistance of a Disk Superalloy

## **Abstract**

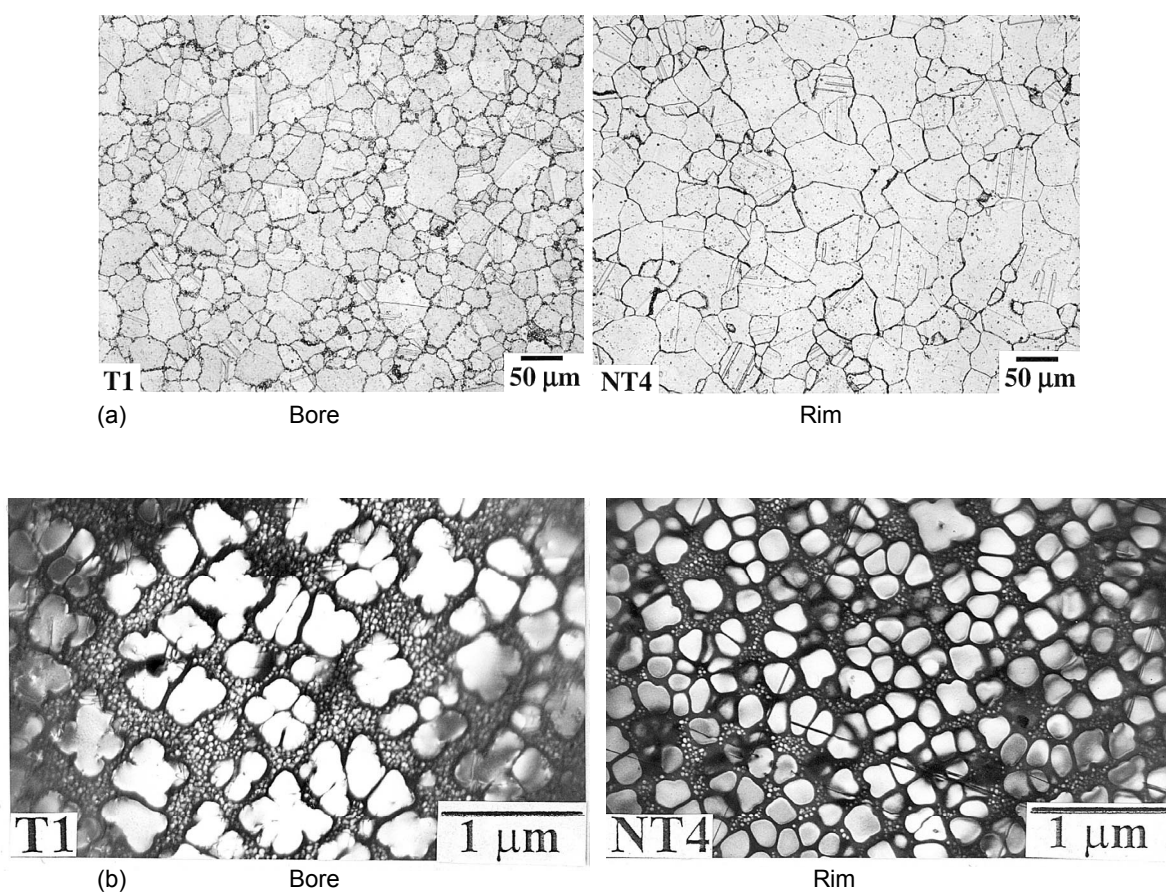
Figure 1.—ME3 microstructure: (a) grain structure, (b)  $\gamma'$  precipitate structure.

Typical microstructures from the test material are shown in figure 1 (ref. 13). The material ranged in average grain size from 25 to 34  $\mu\text{m}$ , and as-large-as grain size of 90 to 170  $\mu\text{m}$ . Mean diameters for secondary gamma prime precipitates ranged from 0.19 to 0.33  $\mu\text{m}$ , and for tertiary gamma prime precipitates ranged from 18 to 39 nm. These differences in specimen microstructure were due to varying prior location of specimens from within disks which had been given intentionally varied solution quench heat treatments (ref. 13). Specimens for each test condition were selected from multiple disks and locations to span this range of microstructure, and associated mechanical response.

maximum stress slightly varied in each test specimen. This could be attributed to differences in specimen mechanical response rooted in varying microstructure (fig. 1), due to varying prior location of specimens from within disks given different solution heat treatment quenches (ref. 13). The effects of cyclic stress variations on observed fatigue life were analyzed and found to be insignificant in most cases. Nevertheless, estimation of concentrated stresses and strains at pits with inclusion of these effects would help identify critical pit stress parameters, refine the estimated critical pit dimensions, and allow their extension to other, untested fatigue conditions.

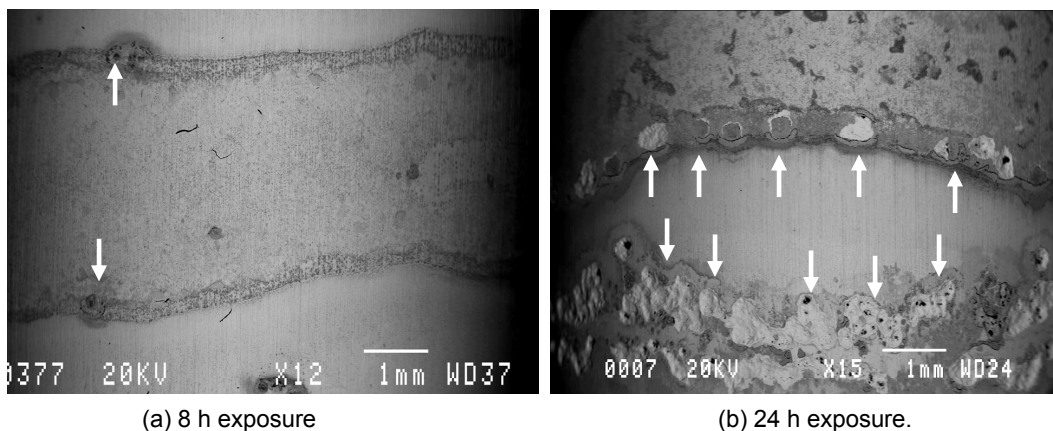
Figure 2.—Corroded fatigue specimens with the loading direction oriented vertically, arrows indicating corrosion pits: (a) 8 h exposure, (b) 24 h exposure.

Fatigue specimen surfaces after the hot corrosion exposures are shown in figure 2. The salt mixture, applied in a ring around the middle of the gage section, melted at 704 °C and caused pits to form within and along the edges of this ring. The 8 h corrosion exposure produced fewer, usually separated pits that were near hemispherical in profile, as indicated by the arrows. The 24 h exposure produced a higher density of pits, which were sometimes joined together along the ring edges, also indicated. The range of pit morphologies captured by 8 and 24 h exposures allowed determination of how variations in pit characteristics influence fatigue life.

The dimensions of pits initiating identifiable fatigue cracks were measured on the fracture surface of each specimen. Pit depth ( $d$ ) and width ( $w$ ) were measured for each initiation site as shown in figure 10, for approximately 3 to 15 initiation sites present on each fracture surface. Pits which caused fatigue cracks had depths of 21 to 100  $\mu\text{m}$  and widths of 71  $\mu\text{m}$  to 4.56 mm. The very large widths sometimes observed were due to the linking of some corrosion pits in the width direction along the edge of the melted salt ring, as evident in figure 2.

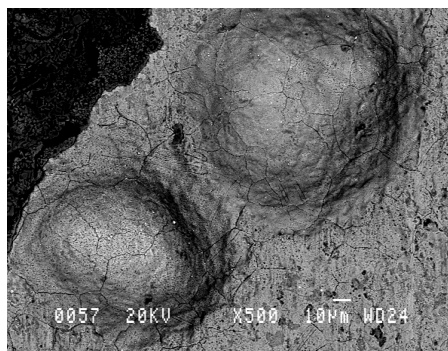
Figure 3.—Corrosion pits with evidence of intergranular attack.

Oxide layers were sometimes retained within and over pits, but in other cases the oxide layers spalled, to openly expose the pits. Open pits are shown at higher magnification in the SEM image of figure 3. The delineation of grain boundaries in the open pit of figure 3 indicates localized corrosion attack at the grain boundaries occurred within these pits. This was easily observed in some, though not all pits.

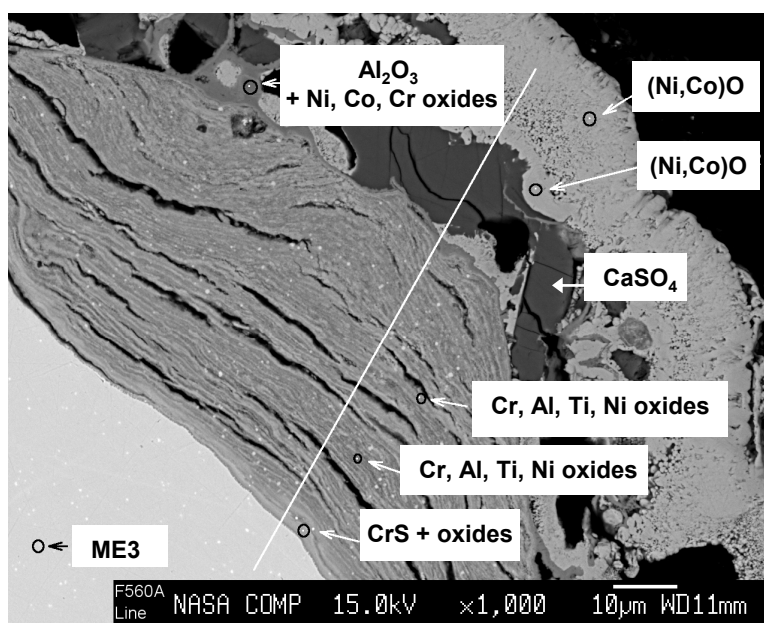
Figure 4.—Corrosion products identified by microprobe on pit cross section.

A cross section containing a pit with the oxide layers still attached is shown in figure 4, from a metallographically prepared section of a specimen. This pit section was analyzed using a scanning electron microprobe, and the major oxide layers in the pit are identified in the figure. Outer porous layers of nickel and cobalt oxide covered entrapped salt particles. Within these outer layers were very fine alternating layers of chromium, aluminum, titanium, and nickel oxides. CrS was present at the inner most layer of attack in the pit. This damage was consistent with a hot corrosion attack mechanism whereby the molten salt breaks down the chromium and aluminum oxides, rendering them nonprotective and allowing sulfur penetration and attack of the substrate to form CrS at the corrosion front (ref. 2).

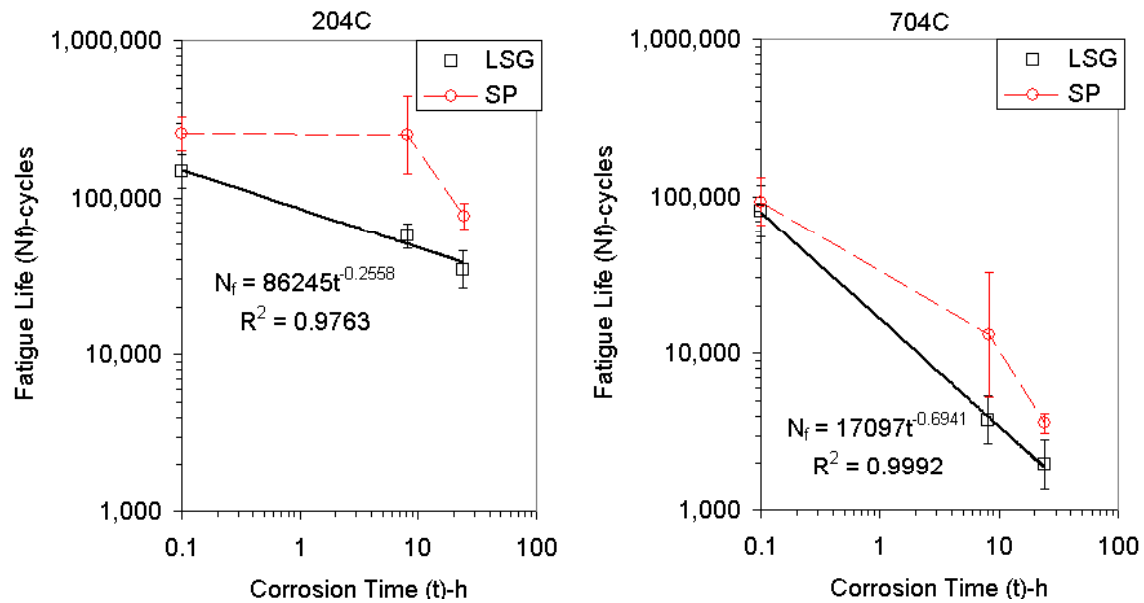
Figure 5.—Comparison of log mean fatigue lives and their 95% confidence intervals.

The lives of low cycle fatigue tests performed at 204 and 704 °C are tabulated in table 1 and compared in figure 5. Evaluations indicated the logarithm of lives could be treated as normally distributed, so mean lives were computed from the log(life) values and back transformed for comparisons versus corrosion time in figure 5. Hot corrosion substantially reduced mean fatigue life, by between 60 and 98 percent. The largest reductions were observed in tests at 704 °C, where the LSG+24h corroded condition reduced life from the LSG condition by 98 percent. In tests at 204 °C, this LSG+24h corroded condition reduced mean life by 77 percent. Cyclic fatigue life ( $N_f$ ) approximately varied with hot corrosion time ( $t$ ) according to a power law relationship for LSG specimens:

Shot peening of specimens increased mean life for all conditions, but by varying degrees. The positive effect of shot peening was most pronounced for specimens tested at 204 °C after 8 h corrosion exposure. As shown in figure 5, whereas the mean fatigue life of the unpeened specimens tested at these conditions was reduced by over 50 percent, the shot peened specimens given the same 8 h exposure showed equivalent mean life to the unexposed specimens. However, for the specimens given 24 h of corrosion exposure and tested at 204 °C, shot peening was not able to compensate for the corrosion damage and accordingly the SP+24h fatigue life was considerably shorter than for the unexposed specimens. For tests at 704 °C after both corrosion times, shot peening did not negate the effects of subsequent hot corrosion on mean fatigue life. The power law relationship with corrosion time was less applicable here.

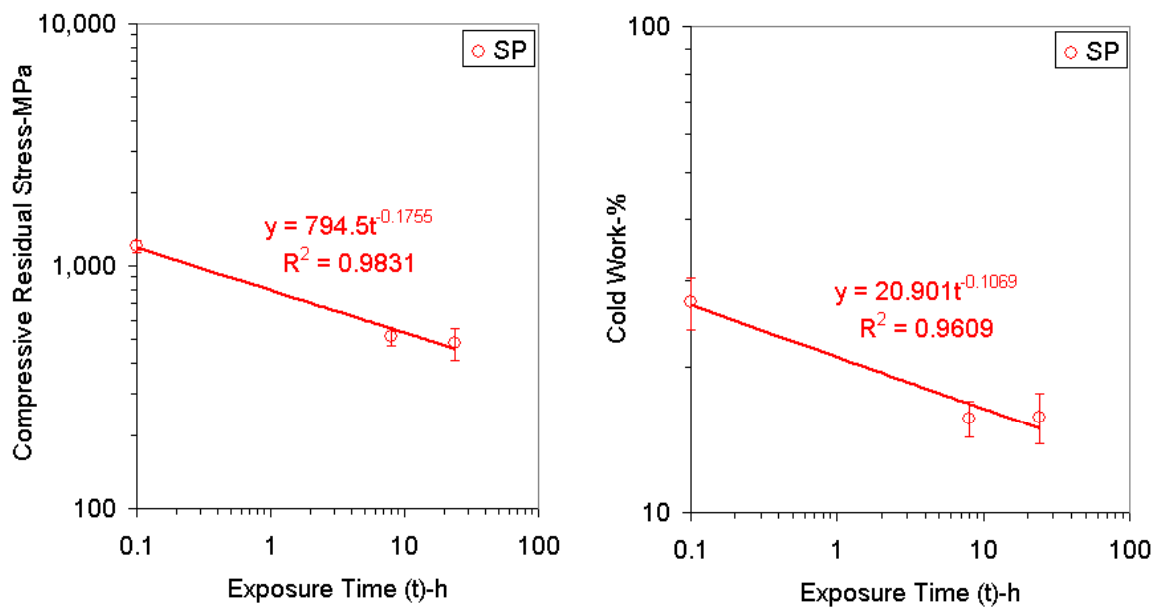
Figure 6.—Comparisons of mean surface residual stress and cold work for shot peened fatigue specimen sections exposed at 704 °C, with their 95% confidence intervals.

The variation in benefits of shot peening on life could be due in part to the evolution of associated residual stress and cold work during corrosion treatments and fatigue testing. Therefore, axial residual stress and cold work were determined by X-ray diffraction on sections from an untested shot peened specimen given exposure times of 0, 8, and 24 h at 704 °C. Mean residual stress and cold work at the surface are compared as functions of exposure in figures 6 and 7. Mean compressive residual stress (CRS) strongly decreased in magnitude with just 8 h exposure at 704 °C, while further exposure to 24 h produced only a small additional decrease in residual stresses, according to the power law relationship shown below:

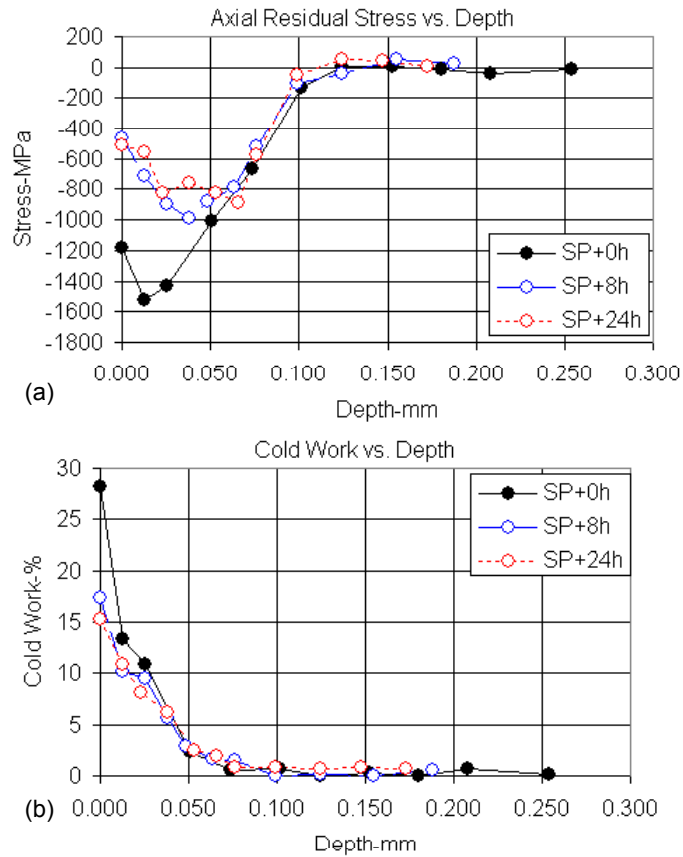
Figure 7.—Comparisons of (a) axial residual stress and (b) cold work with depth for shot peened fatigue specimen sections exposed at 704 °C.

Cold work magnitude similarly decreased with exposure time. Corresponding plots of residual stress and cold work versus depth are compared for the three conditions in figure 7. Maximum compressive residual

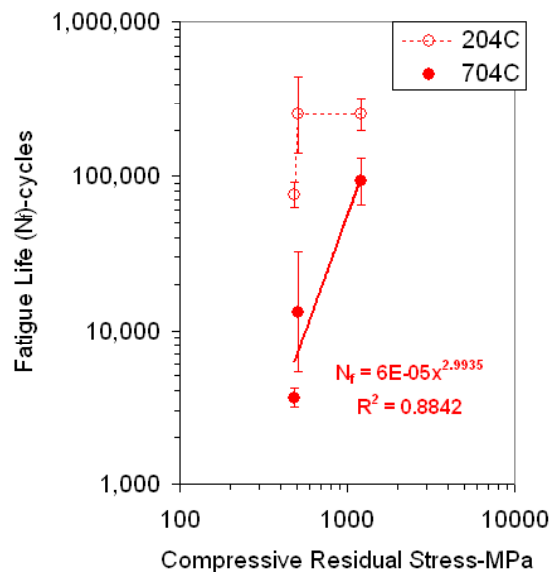
Figure 8.—Correlation of mean fatigue life with surface compressive residual stress for shot peened fatigue specimens, where corroded specimens have reduced stresses.

Mean compressive residual stresses at the surface versus mean log(life) of shot peened specimens are shown in figure 8. The reductions of beneficial compressive residual stress with exposure time were often associated with reductions in mean fatigue life of shot peened specimens, but not consistently. A corrosion time of 8 h at 704 °C strongly reduced compressive residual stress by 57 percent, where the accompanying mean fatigue life was reduced by 86 percent. However, continuing exposure to 24 h further decreased compressive residual stress by only 6 percent, while further decreasing fatigue life 73 percent, a very significant reduction. This lack of consistent time dependence was even more evident in fatigue tests at 204 °C, where mean life was unchanged after 8 h corrosion, but dropped after 24 h corrosion by 70 percent.

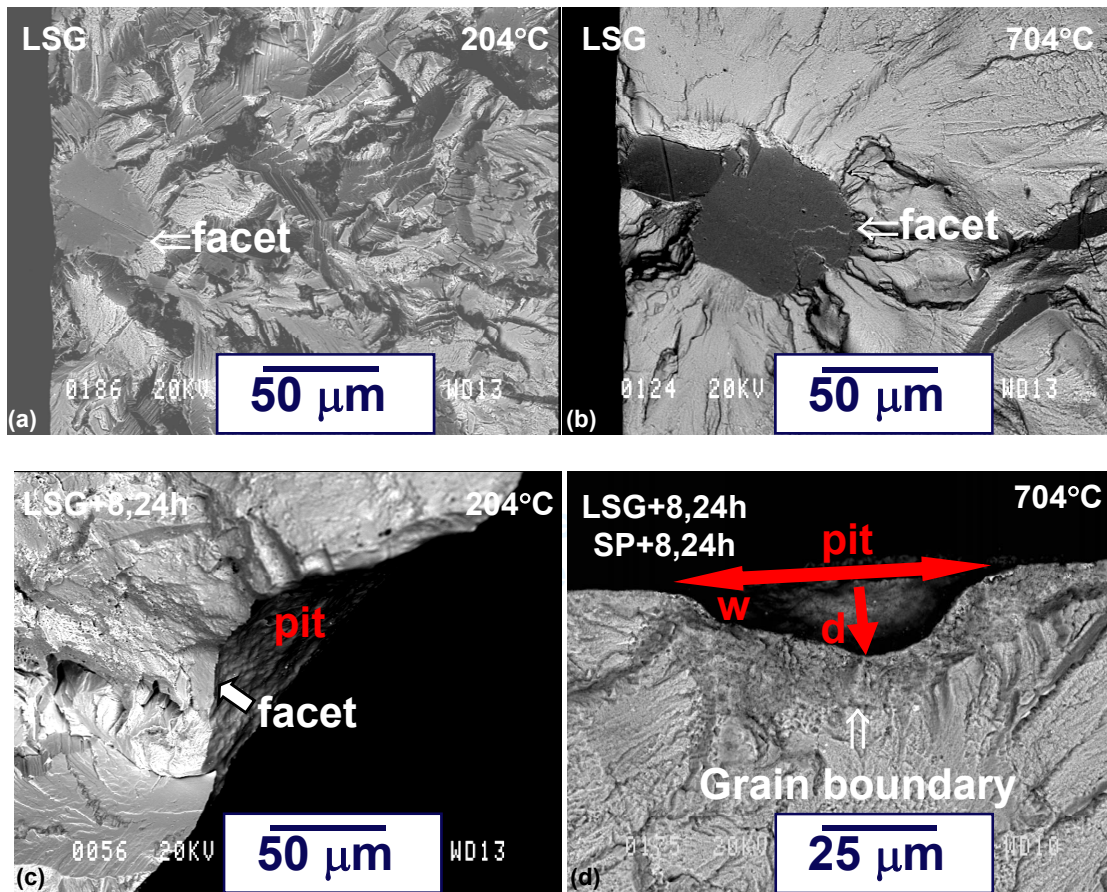
Figure 9.—Typical fatigue failure initiation points: (a) LSG at 204 °C; (b) LSG at 704 °C; (c) LSG + 8,24 h at 204 °C; and (d) LSG + 8,24 h and SP+8,24 h at 704 °C.

The failure initiation sites were identified for all specimens, with typical results compared in figure 9. Failures for specimens not corroded occurred at relatively large grains, which failed on crystallographic planes. Such failures are often termed "facet" grain failures, and are commonly observed in ME3 (ref. 17). Some of these failures were at or near the specimen surfaces, while others were internal and away from the surface. Failures of most corroded specimens initiated from hot corrosion pits at the specimen surface. For specimens tested at 204 °C, failures usually initiated at grain facets along the pits. In corroded specimens tested at 704 °C, cracks initiated along grain boundaries connected to the pit surfaces. Multiple failure initiation sites were present for specimens corroded 24 h, while fewer or even single failure initiation sites were present for specimens corroded 8 h. These results consistently applied for all corroded specimens having large reductions in life from the baselines.

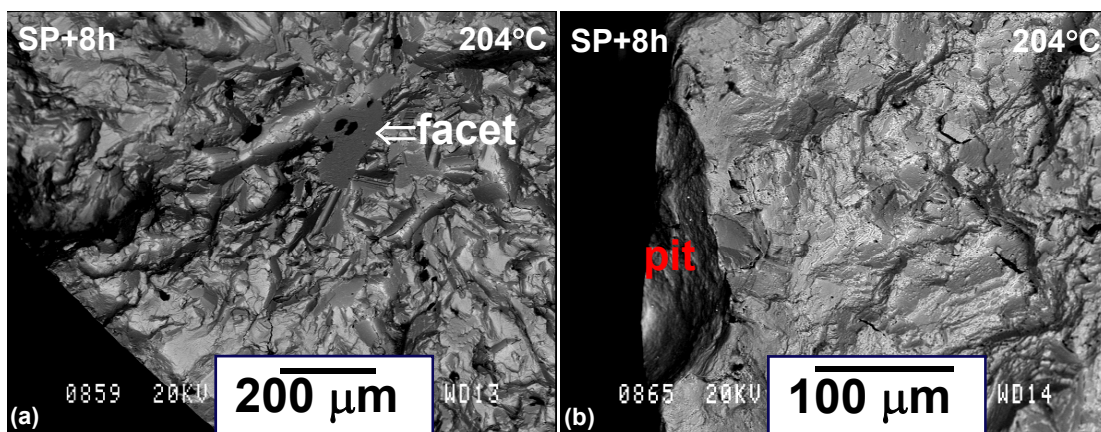
Figure 10.—Failure initiation points for SP+8h specimen tested at 204 °C, having lowest life for this condition of 122,917 cycles: (a) internal grain facet, (b) surface pit.

However, the failure mode shifted for most, though not all, SP+8h corroded specimens tested at 204 °C, which had no reduction in mean life. For this one case, cracks initiated at internal grain facets rather than at surface pits to cause failure in four out of five of the SP+8h specimens, giving no reductions in mean life. The remaining specimen had cracks initiated both from an internal grain facet and at two surface pits (fig. 10), and lower resulting life. Thus for the SP+8h condition with tests conducted at 204 °C, compressive residual stresses produced by shot peening were apparently sufficient to mostly suppress fatigue cracking at surface pits, which greatly benefited fatigue life. Yet, in all other SP+8,24h test conditions, the compressive residual stresses were apparently reduced by plastic flow and time-dependent stress relaxation sufficiently to still allow fatigue cracking at the pits, with large reductions in life.

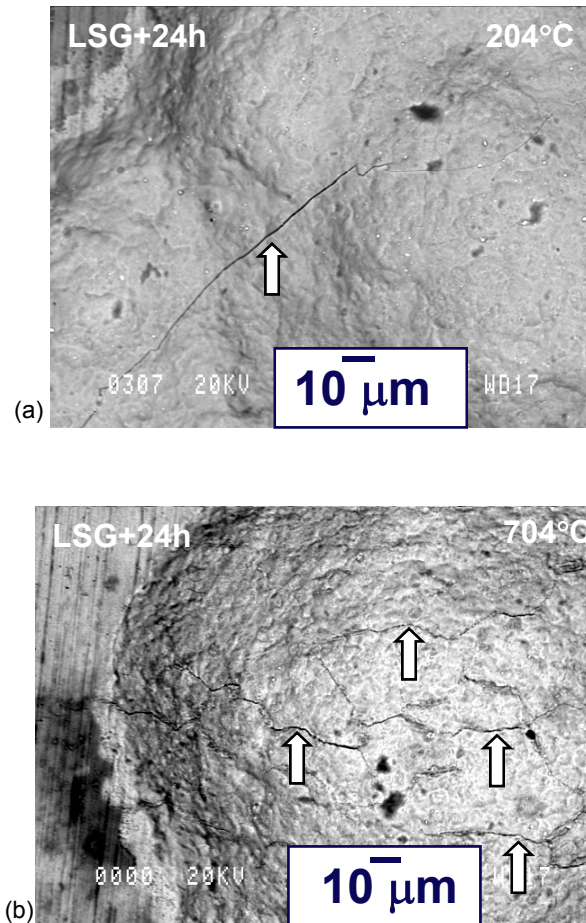
Figure 11.—Cracking at pits in interrupted test specimens with the loading direction oriented vertically, arrows indicating cracks, (a) 204 °C, transgranular cracks observed at crystallographic facets at 33 to 55% of cyclic life; (b) 704 °C, intergranular cracks at 5 to 10% of cyclic life.

Several fatigue tests were interrupted at cycling intervals, in order to study the onset of crack initiation and assess the mechanisms of crack initiation and propagation at pits. Typical pits on the surfaces of LSG+24h specimens are shown fatigue cycles at 204 and 704 °C in figure 11, with the load direction oriented vertically. Specimens tested at 204 °C did not have identifiable fatigue cracks within the pits when first interrupted at 250 cycles. However, specimens tested at 704 °C for only 250 cycles already had cracks present, with the cracks initiated along grain boundaries nearly normal to the loading axis, figure 11(b). Multiple cracks initiated along grain boundaries within the corrosion pits very early in

tests at 704 °C, which coalesced and grew for the remaining large majority of life to cause failure. In the case of tests at 204 °C, the first cracks were not detected until approximately 1/3 to 1/2 of life was consumed for each corroded condition, e.g., at least 10,000 cycles for the LSG+24h case. In contrast to the 704 °C tests, the crack initiation within the corrosion pits at 204 °C was transgranular with the cracks appearing on apparent crystallographic facets as shown in figure 11(a). This indicated a substantial portion of fatigue life was consumed in the process of fatigue crack initiation at 204 °C. Conversely, most of the fatigue life at 704 °C was apparently taken up in propagation of fatigue cracks, initiated very early in life, at grain boundaries often attacked and weakened by corrosion in the pits (fig. 3). This is consistent with the greater reductions in life observed for corroded specimens tested at 704 °C.

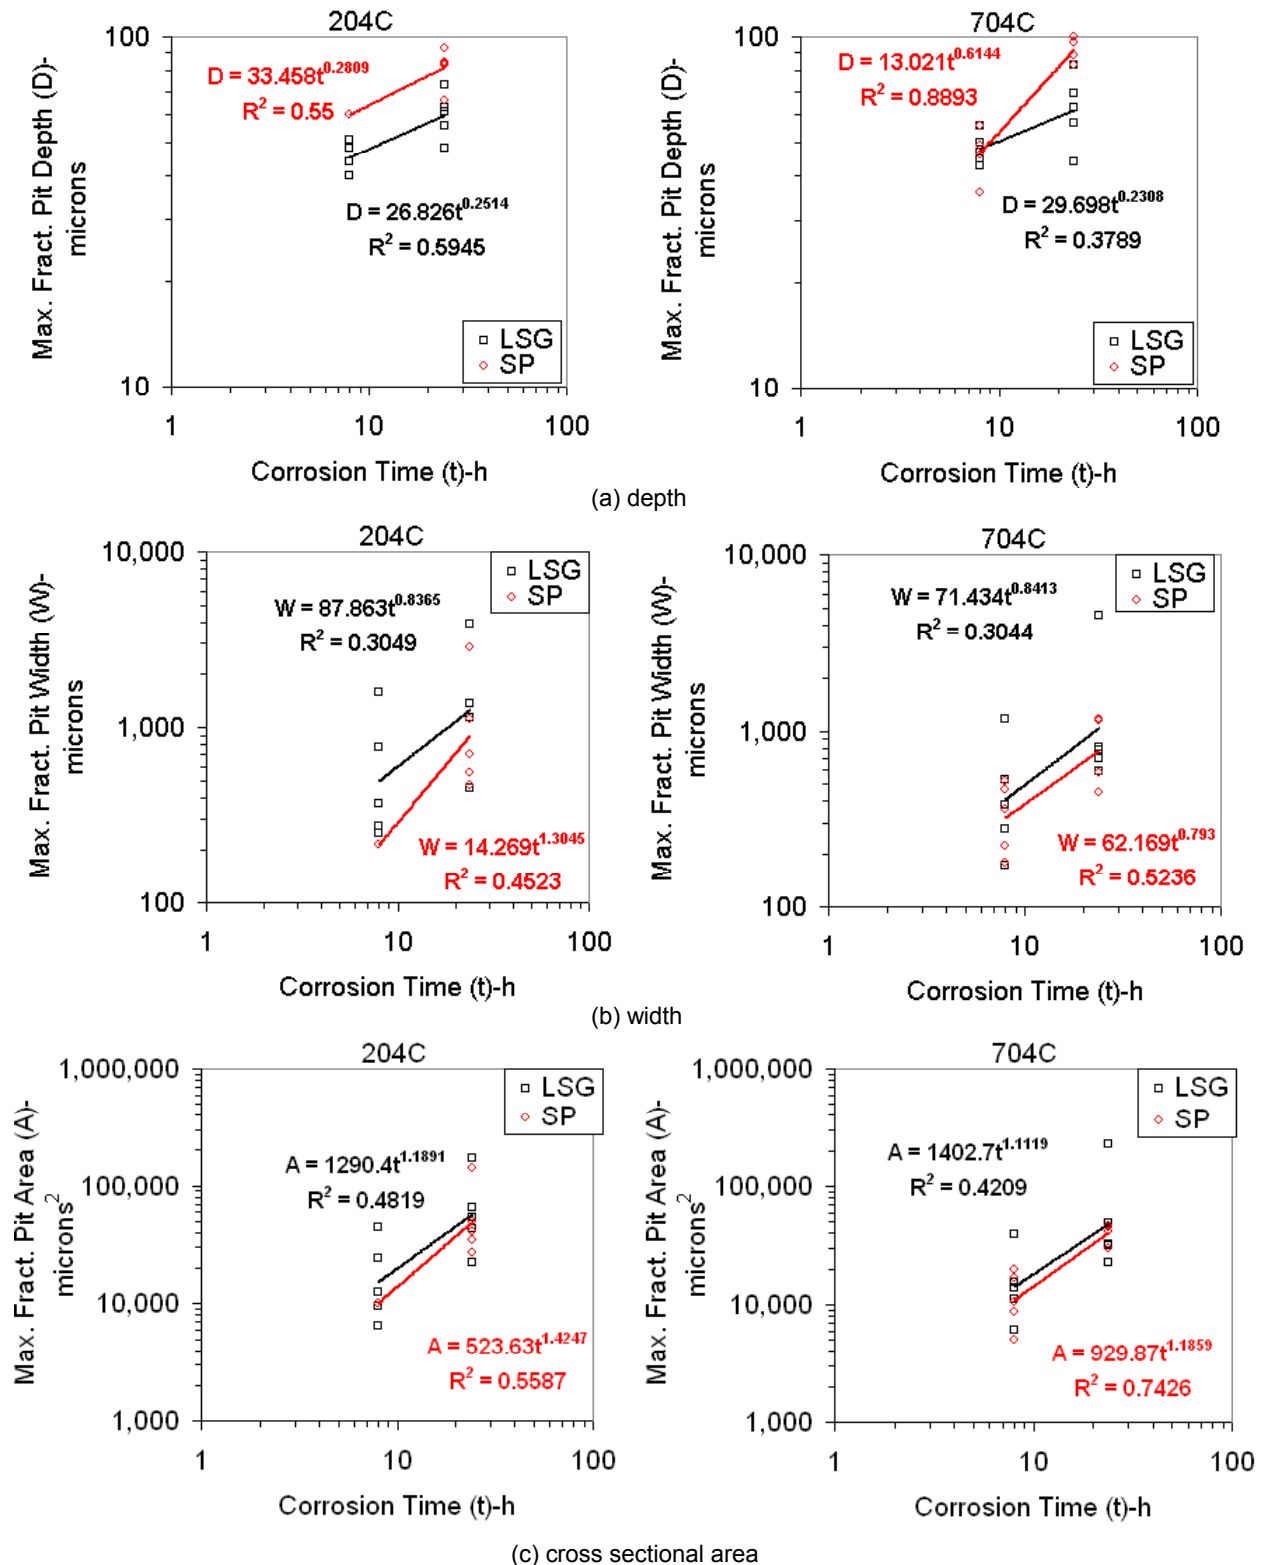
Figure 12.—Relationships between corrosion time and the maximum pit (a) depth, (b) width, and (c) cross sectional area on each corroded specimen's fracture surface.

Fatigue damage often first initiates cracks at the largest defects. Therefore, the largest pit depth, width, and cross sectional area measured of the cracked pits on each fracture surface were first evaluated. Maximum pit dimensions were first compared versus corrosion time, as exemplified in the plot of maximum pit depth for specimens tested at 204 and 704 °C versus corrosion time in figure 12 and are summarized in table 2. Maximum pit depth, width, and area all increased significantly with corrosion time. However, there was substantial overlap in values across time in most cases. These maximum pit dimensions are compared versus fatigue lives for each specimen in figure 13 and are summarized in table 3. An increase of each pit dimension significantly decreased fatigue life. This is in agreement with previous work where fatigue life was related to pit depth (refs. 5 and 7). The different pit dimensions were cross-correlated with specimen life, in that lower specimen life occurred in specimens having larger pit depth, width, and area. So step-wise multiple linear regression could not be used to determine the best predictors and most influential dimensions. However, comparison of the coefficients of determination for each separately regressed dimension indicated pit cross sectional area usually correlated with life better than either pit depth or width.

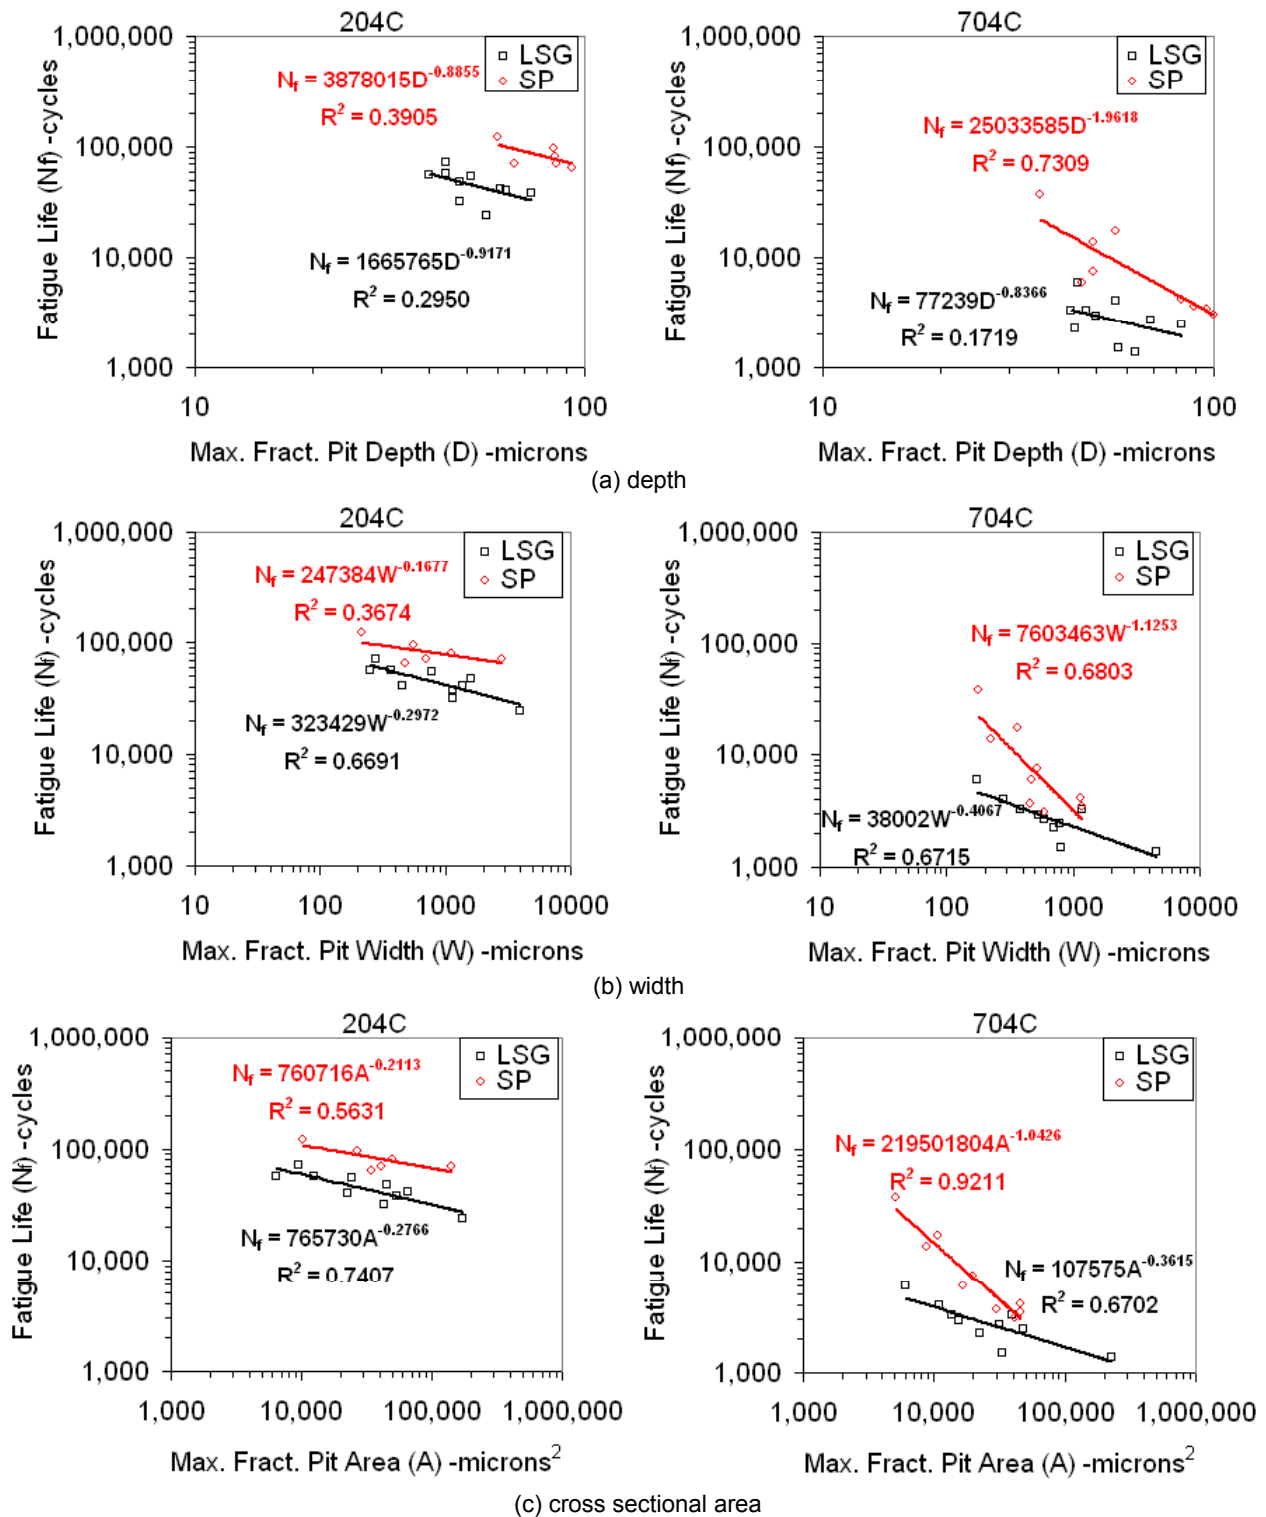
Figure 13.—Relationships between fatigue life and each corroded specimen's maximum pit (a) depth, (b) width, and (c) cross sectional area on it's fracture surface.

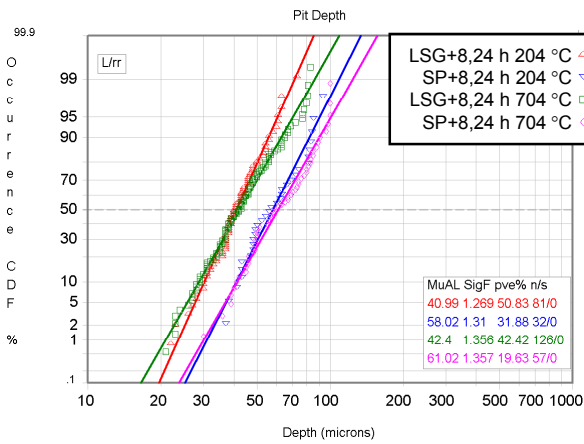
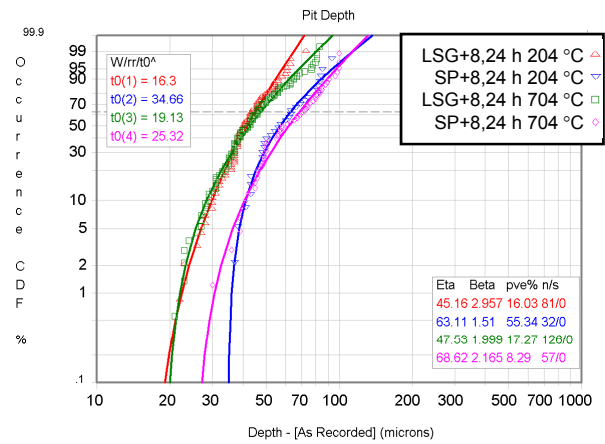
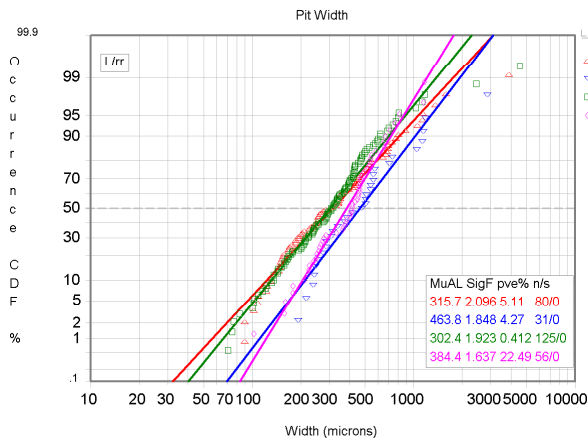
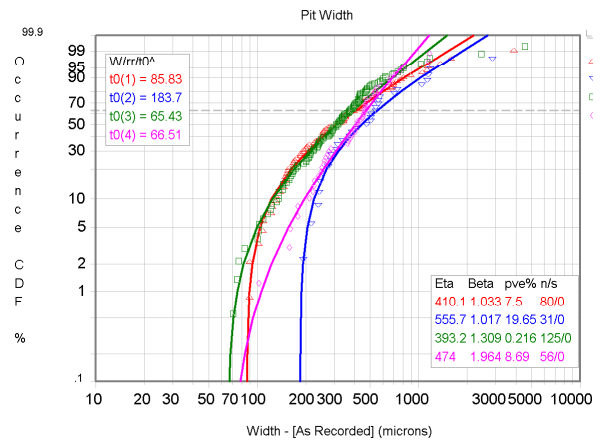
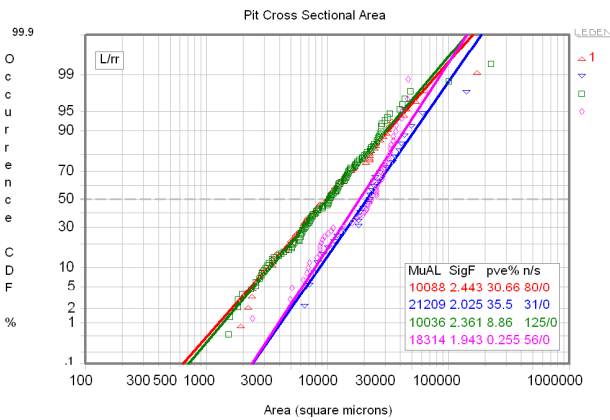
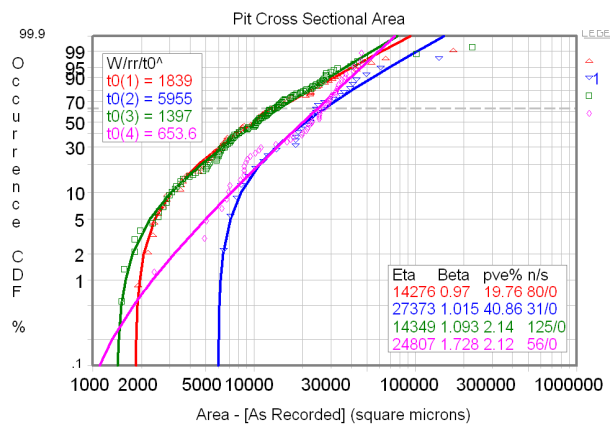
Figure 14.—Cumulative probability of cracking versus pit (a) depth, (b) width, and (c) cross sectional area.

The above correlations of increasing fatigue life with decreasing pit size suggest a “critical” pit size could exist below which no fatigue cracks initiate to cause premature failure. Pits of a relatively wide range of sizes were intentionally produced, and many were found to initiate fatigue cracks on the fracture surfaces. Therefore, cumulative probabilities for cracking at pits could be estimated, versus ranked dimensions of all pits initiating cracks on the fracture surfaces of all specimens. Critical values of pit depth, width, and area having minimum ( $P = 0.001$ ) probabilities of initiating fatigue cracks were thereby estimated, and are tabulated in table 4. In this evaluation, both log normal and three parameter Weibull distribution assumptions were found to give good fits, figure 14.

Pit depth was found to give better correlations than other pit dimensions using both log normal and three parameter Weibull equations, table 3, and figure 14. Coefficients of determination were well above 0.90 for all conditions using pit depth. Pit area had similar, satisfactory correlations for fatigue specimens tested at 204 °C, but somewhat lower values for those tested at 704 °C. This appeared related to several outlier width and area values in each case. These high outlier values were from corrosion pits linked in the width direction along the edge of the melted salt mixture, as seen in figure 2. These joined pits perturbed the curve fits, but were nevertheless important based on their demonstrated influences on life, figure 13. They contributed to the curvature in the Weibull plots, which required fits using the three parameter curved Weibull equation rather than the two parameter straight Weibull equation, where the offset value  $t_0$  is held at zero. Pit width gave mixed, intermediate results, with high width values again producing curvature in both log normal and Weibull plots.

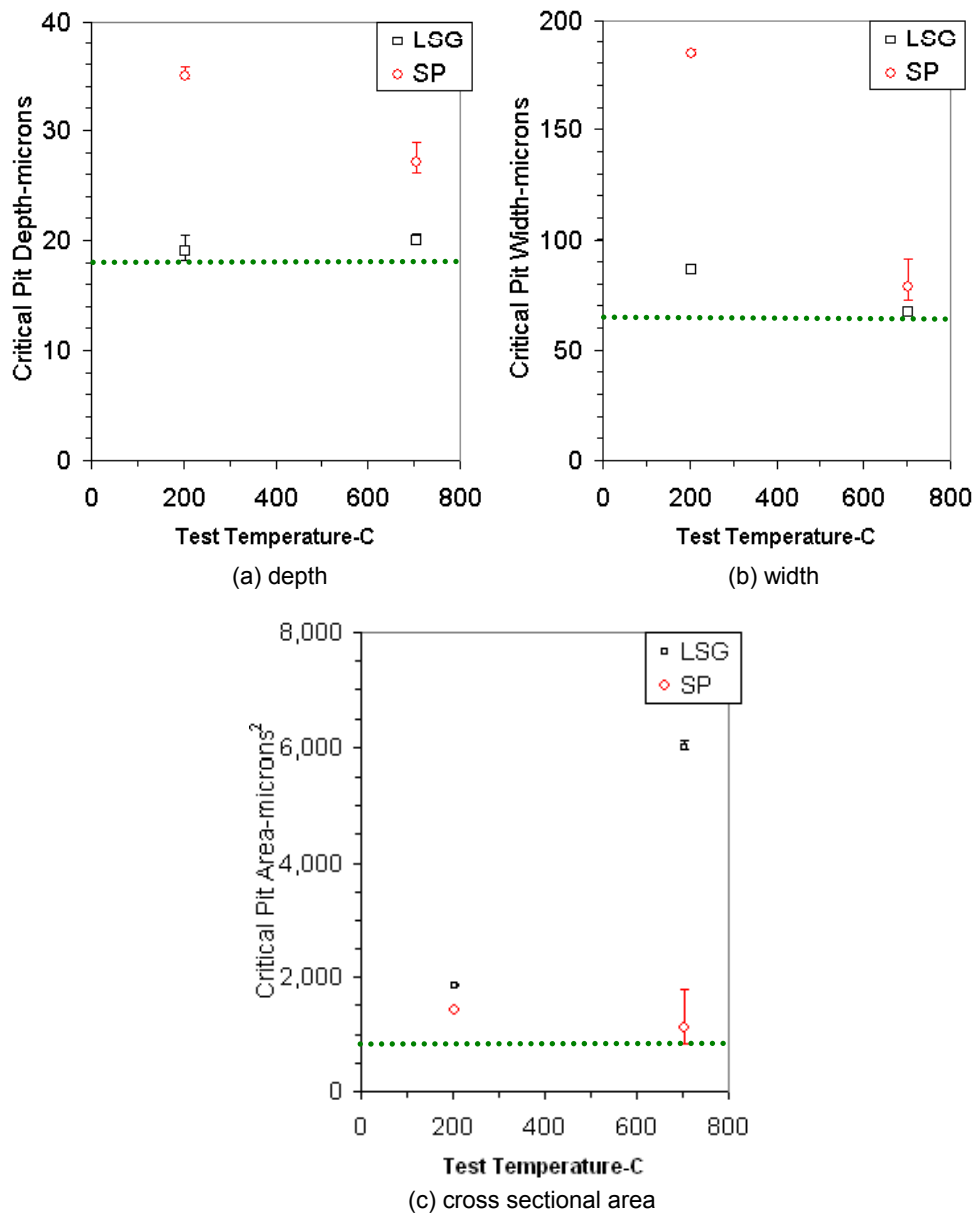
Figure 15.—Critical pit dimensions with their 95% confidence intervals estimated by 3 parameter Weibull equations to have a minimum probability for cracking  $P=0.001$  at the chosen fatigue test conditions: (a) depth, (b) width, and (c) cross sectional area.

As summarized in table 4, “critical” pit depths of 16 to 20  $\mu\text{m}$  were estimated to have a minimum probability of  $P = 0.001$  for initiating cracks in LSG+8,24h specimens tested at 204 and 704  $^{\circ}\text{C}$ . For SP+8,24h specimens, the estimated critical pit depth increased to 24 to 35  $\mu\text{m}$ . Critical widths and areas also increased in the low stress ground specimens compared to the shot peened specimens at each test temperature. Selection of the log normal distribution assumption usually gave lower critical pit dimension estimates, which could be considered more conservative. However, the three parameter Weibull fits often did a better job modeling curvature in the size distributions, with more accurate capture of minimum experimental values. So overall critical limits for pit depth, width, and area were estimated from the three parameter Weibull fits, and are shown in figures 15 and 16. Overall critical values for pit depth of 18  $\mu\text{m}$ , width of 63  $\mu\text{m}$ , and cross sectional area of 800  $\mu\text{m}^2$  are suggested here, with no benefits credited for shot peening. Note that these values are not exactly self-consistent, as a pit having an area of 800  $\mu\text{m}^2$  and depth of 18  $\mu\text{m}$  could have a width of no more than 57  $\mu\text{m}$  to avoid potential cracking. Conversely, a pit having an area of 800  $\mu\text{m}^2$  and width of 63  $\mu\text{m}$  could have a depth of no more than 16  $\mu\text{m}$  to avoid potential cracking. This lack of exact self-consistency can be attributed to residual errors in the regressions and their estimates of critical pit dimensions, as well as elliptical approximations of pit shape.

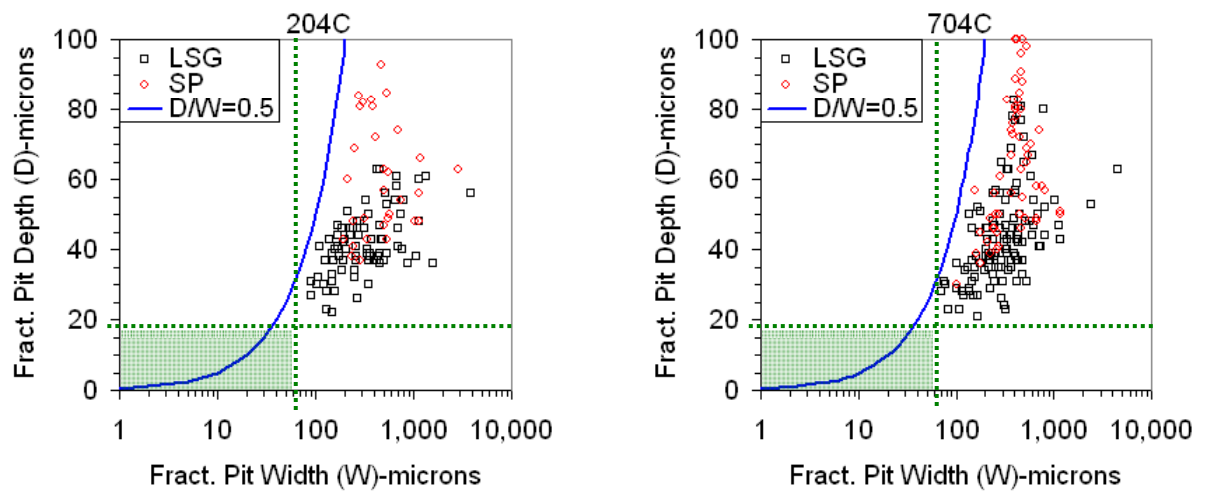
Figure 16.—Depth versus width of all pits initiating fatigue cracks on each specimen's fracture surface, with shaded region indicating where pits have minimal probability of initiating fatigue cracks for the current test conditions.

In figure 16, plots of width versus depth are shown for all pits initiating cracks in all corroded specimens. These pits all had aspect ratios (depth/width) less than 0.5, the value corresponding to a hemisphere. Smaller pits had aspect ratios approaching this value. This pit shape appeared to be an inherent characteristic of many pits that cracked. Some of the low observed pit aspect ratios were due to the joining of pits along the corrosion ring. Windows of pit depth and width dimensions estimated to have minimal potential for cracking are indicated. However, such estimates are preliminary, and need to be updated as tests at other fatigue conditions are conducted and analyzed.

While maximum pit cross sectional area correlated better with fatigue life than depth or width, a more important aspect may be the concentrated cyclic stresses and strains generated at each pit as functions of its dimensions and the test conditions. As a first step in this direction, a three-dimensional elastic finite element model was used to assess the effects of pit shape on stress concentration. The elastic stress concentration produced by a hemispherical pit with a depth/width aspect ratio of 0.5 was compared to that of a pit extended in one direction by 100 percent, producing an ellipsoid having an aspect ratio of 0.25. The single extended axis of the ellipsoid was oriented normal to the loading direction and parallel to the surface (NP), normal to the loading direction and normal to the surface (NN), and parallel to the loading direction (P). The elastic stress concentration of the hemispherical pit was estimated to be 2.0. For the ellipsoidal pit, the stress concentration was dependent on pit orientation. The P pit had a lower stress concentration of 1.4, while the NP and NN pits had higher stress concentrations of 2.5 to 2.6. These concentrated stresses would be limited by plastic flow at the pits when exceeding the yield stress, which is possible in the present fatigue tests. But this would result in more plastic deformation and consumption of ductility for pits having higher elastic stress concentrations. Overall, the elastic model results do signify that pit morphology and orientation do influence the concentrated stresses and strains generated at a pit, and that extended, wide pits could have higher stresses and resulting propensity for cracking than hemispherical pits at a constant depth, supporting the results in figure 16.
